Skirden Beck RiverBlitz

Overview

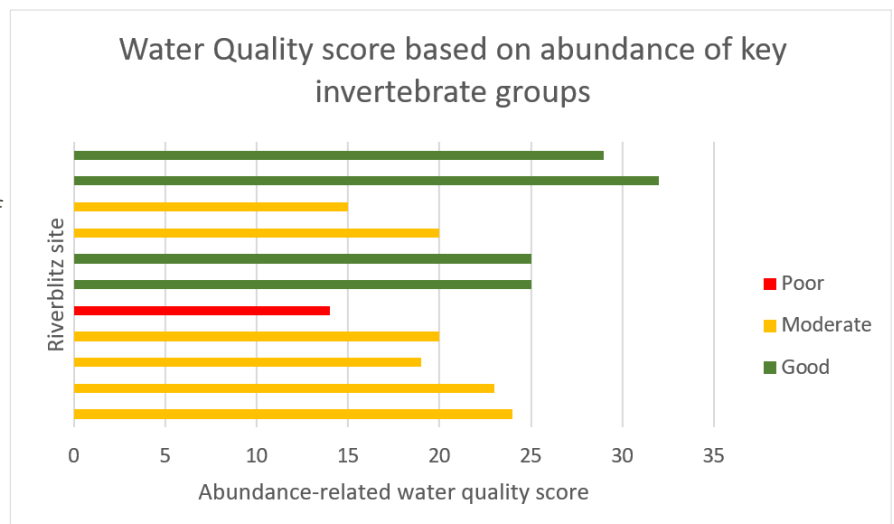
Our volunteers performed 3-minute kick samples at each site and identified all invertebrates to an Extended Riverfly standard. This gives a good indication of water quality (WQ). From the graph (right), we can see the majority of sites in the Skirden Beck catchment scored 'moderate' water quality, with 4 sites being 'good' (WQ ≥ 25). Riverblitz results can prompt investigative monitoring to identify issues at sites with poor scores.

Across the sites, our most abundant macroinvertebrate group was **olive's (mayflies)**, our rarest group were **weighted case maker's (cased caddisfly)**. And the highest scoring group found were **stoneflies**.

Note: Scoring grades are arbitrary, and derived from comparison of scores gained on the day. Note also that the site numbers have deliberately not been revealed.

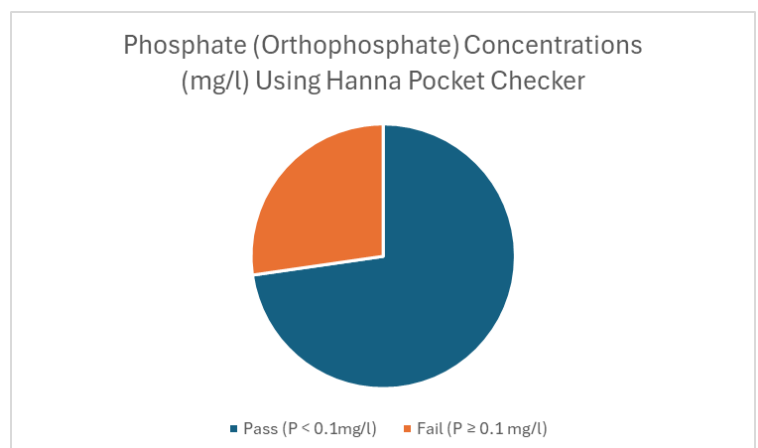
As well as invertebrates, we tested water for orthophosphate levels using Hanna Pocket Phosphate Checkers, which helps the RRT team to pinpoint potential sources of phosphate pollution, which can cause issues for river health. Our RiverBlitz data showed most sites on the day 'passed', as their phosphate levels were under the threshold that the Water Framework Directive deems to be unacceptable.

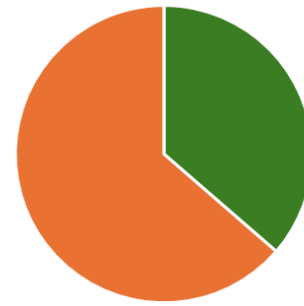
E.coli (CFU/100ml) at Sites across Skirden Beck

Water Rangers kits allow communities with varied scientific experience to preform quick water chemistry tests. Water Rangers kits were used during the Skirden Beck RiverBlitz to test water samples for phosphate and nitrate pollution, and a multitude of physical parameters (pH, temperature, conductivity) and chloride. Additionally, we tested for E.coli CFU (coliform forming units) and data revealed the majority of sites in the catchment measured above 900 cfu/100ml meaning they exceeded the threshold for safe bathing water quality.

■ Good/Sufficient (EC: ≤900 cfu/100ml) ■ Poor (EC: >900 cfu/100ml)

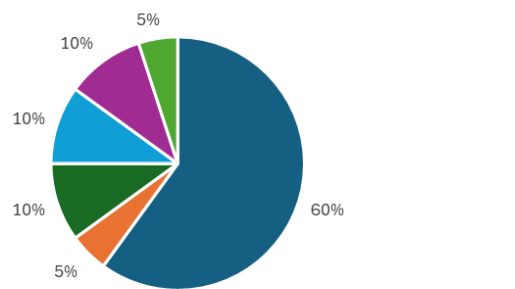
Land Use (%)

■ Grazing grassland ■ Woodland ■ Man-made ■ Arable ■ Urban ■ Meadow (Ungrazed)

The data collected relating to habitat features across the catchment revealed high proportions of agriculture, with **grazing grassland** to be the **predominant land use (60%)**, followed by manmade (10%), arable (10%) and urban (10%). Issues with bank erosion were highlighted with **70% of sites having earthy cliffs** and 10% of sites having 'poached' banks. Positively, **73% of sites noted tree presence** and **Himalayan balsam was absent from 64% of sites**, with only 9% of sites surveyed having abundant balsam.
