# Trawden Brook RiverBlitz

## Overview

On Saturday 24th August we held a fantastic RiverBlitz event in the Trawden Brook Ribble catchment, collecting water chemistry, habitat quality and biological community data across 6 freshwater sites. With the help from 6 wonderful volunteers, we collated a comprehensive picture of water quality across the catchment, the results of which will inform focus for farm advice work, habitat improvements and further monitoring.

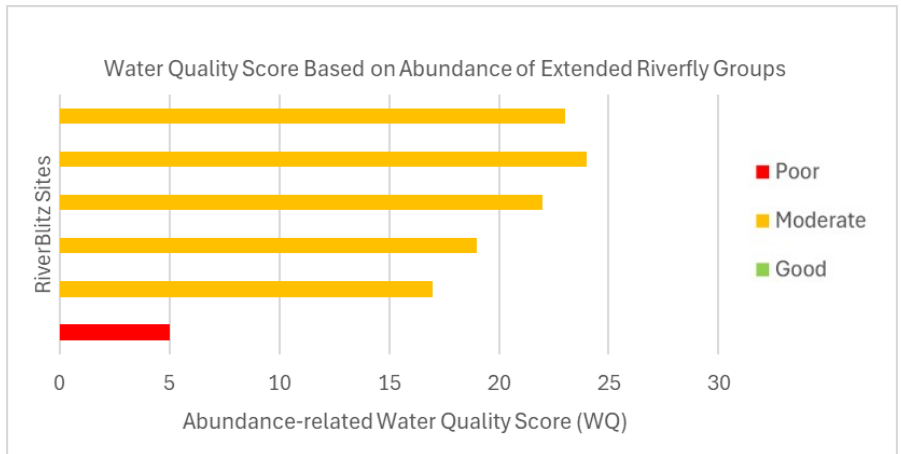
Our volunteers performed 3-minute kick samples at each site and identified all invertebrates to an Extended Riverfly standard. This gives a good indication of water quality (WQ). From the graph (right), we can see the majority of sites in the Trawden Brook catchment scored 'Moderate' water quality (WQ < 15-25). RiverBlitz results can prompt investigative monitoring to identify issues at sites with poor scores.

**Note: Scoring grades are arbitrary, and derived from comparison of scores gained on the day. Note also that the site numbers have purposefully not been revealed.**

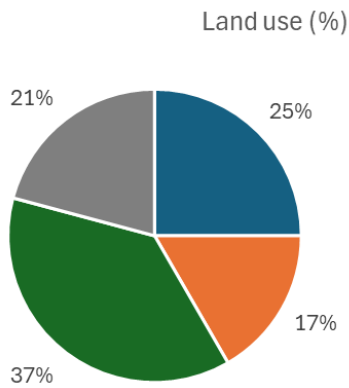
Himalayan Balsam Presence (%)

The data collected relating to habitat features across the catchment confirmed high proportions of **woodland**, the **most predominant land use (37%)**, followed by **ungrazed grassland (25%)**, urban (21%), and grazing grassland (17%). Some issues with bank erosion were suggested with **33% of sites having earth cliffs**, however, no sites had 'poached' banks, and livestock were only able to access the river at one site. Additionally, **66% of sites noted tree presence on both banksides** and positively, **Himalayan balsam was absent at 83% of sites (0% coverage)**.
