# Upper Ribble RiverBlitz

## Overview

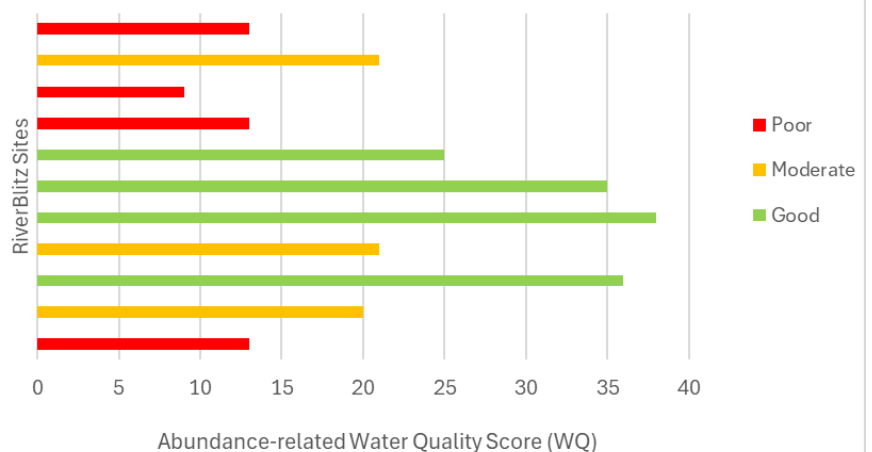
Water Quality Score Based on Abundance of Extended Riverfly Groups

Our volunteers performed 3-minute kick samples at each site and identified all invertebrates to an Extended Riverfly standard. This gives a good indication of water quality (WQ). From the graph (right), we can see the majority of sites in the Upper Ribble catchment scored either 'Good' ( $WQ \geq 25$ ) or 'Poor' ( $WQ \leq 15$ ) water quality. RiverBlitz results can prompt investigative monitoring to identify issues at sites with poor scores.

**Note: Scoring grades are arbitrary, and derived from comparison of scores gained on the day. Note also that the site numbers have purposefully not been revealed.**

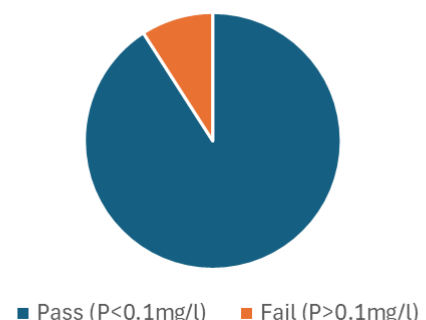
Reactive Phosphorus Concentrations (mg/l) using Hanna Pocket Checker

As well as invertebrates, we tested water for reactive phosphorus levels using Hanna Pocket Phosphate Checkers, which helps the RRT team to pinpoint potential sources of phosphate pollution, which can cause issues for river health. Our RiverBlitz data showed 90% of sites on the day 'passed', as their phosphate levels were under the threshold that the Water Framework Directive deems to be unacceptable.
